BROWNFIELD REDEVELOPMENT ASSESSMENT REPORT

PACKARD PLANT COMPLEX

DETROIT, MICHIGAN

March 24, 1998

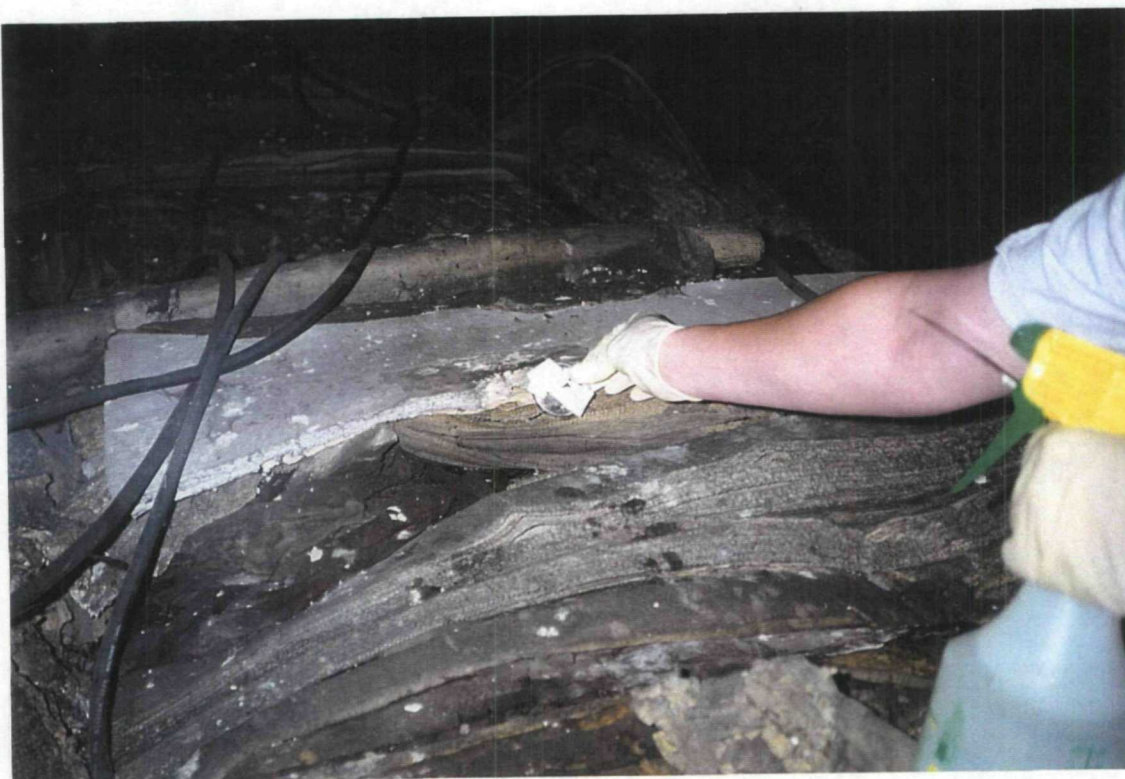
SAMPLE ID:  
HA002-01

Aircell pipewrap from basement of building 38.

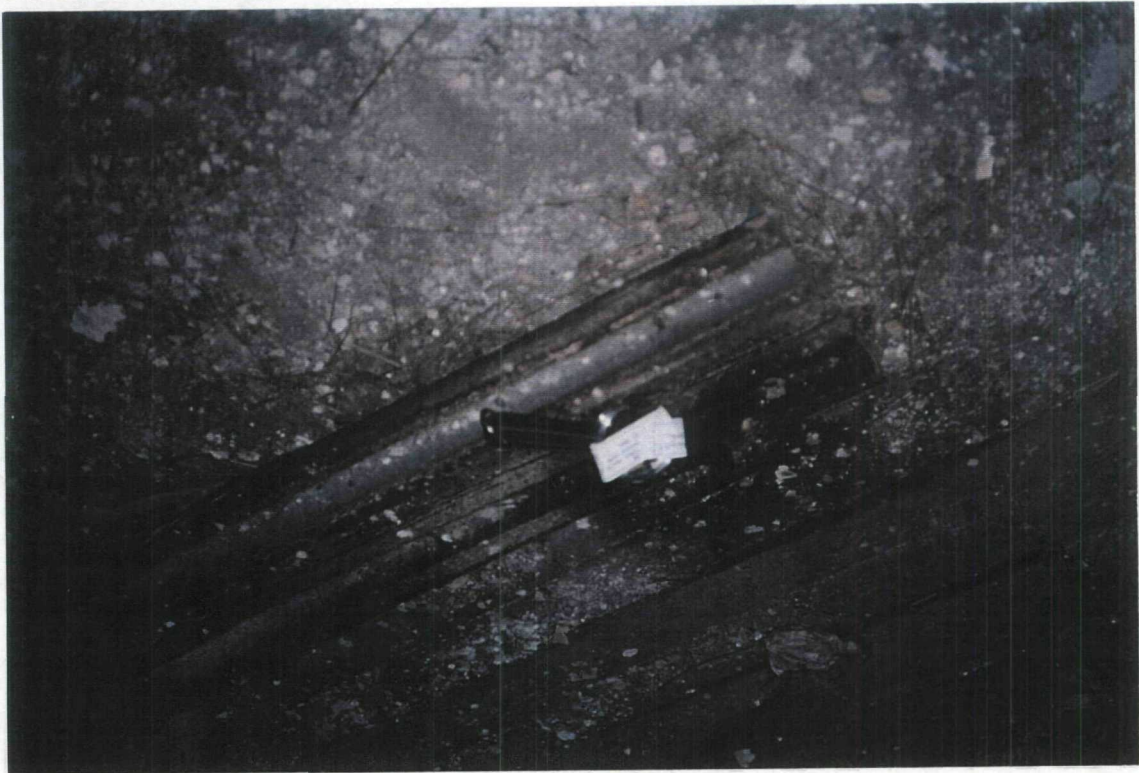
SAMPLE ID:  
HA003-01

DESCRIPTION:  
Aircell pipe wrap collected from third floor of Building 28.

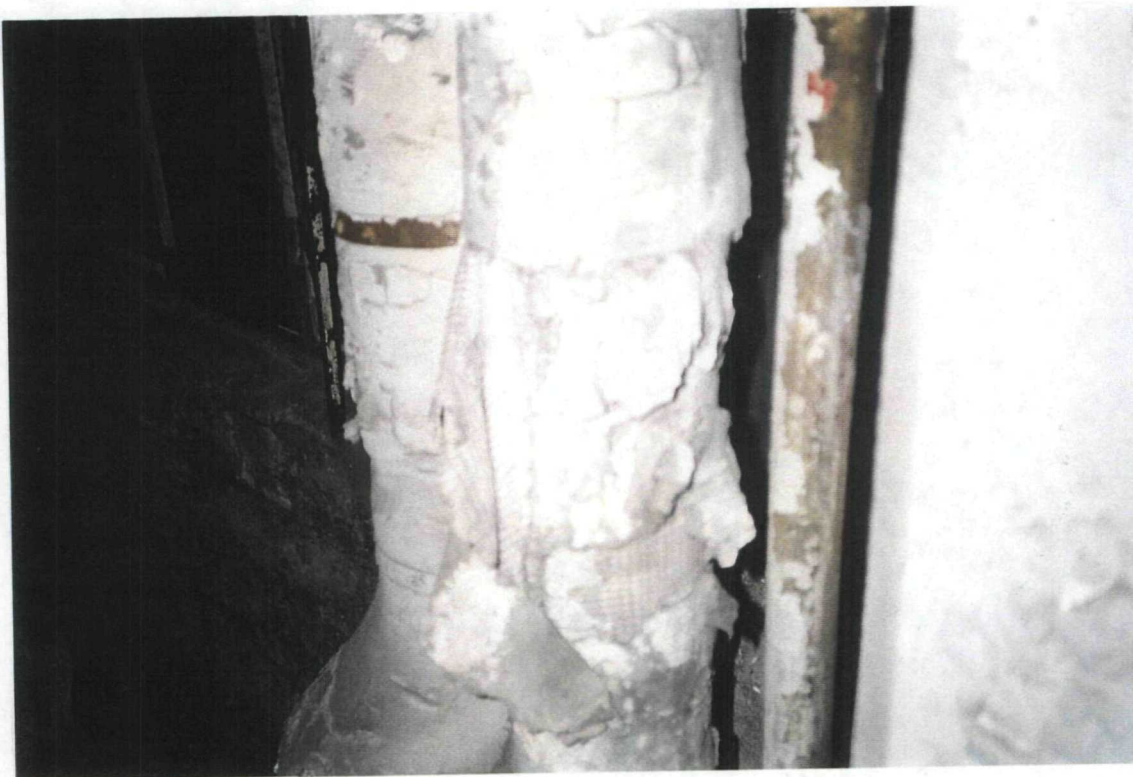
SAMPLE ID:  
HA006-01

Aircell pipewrap on vertical pipes along wall on third floor of Building 18 near the parking ramp area.

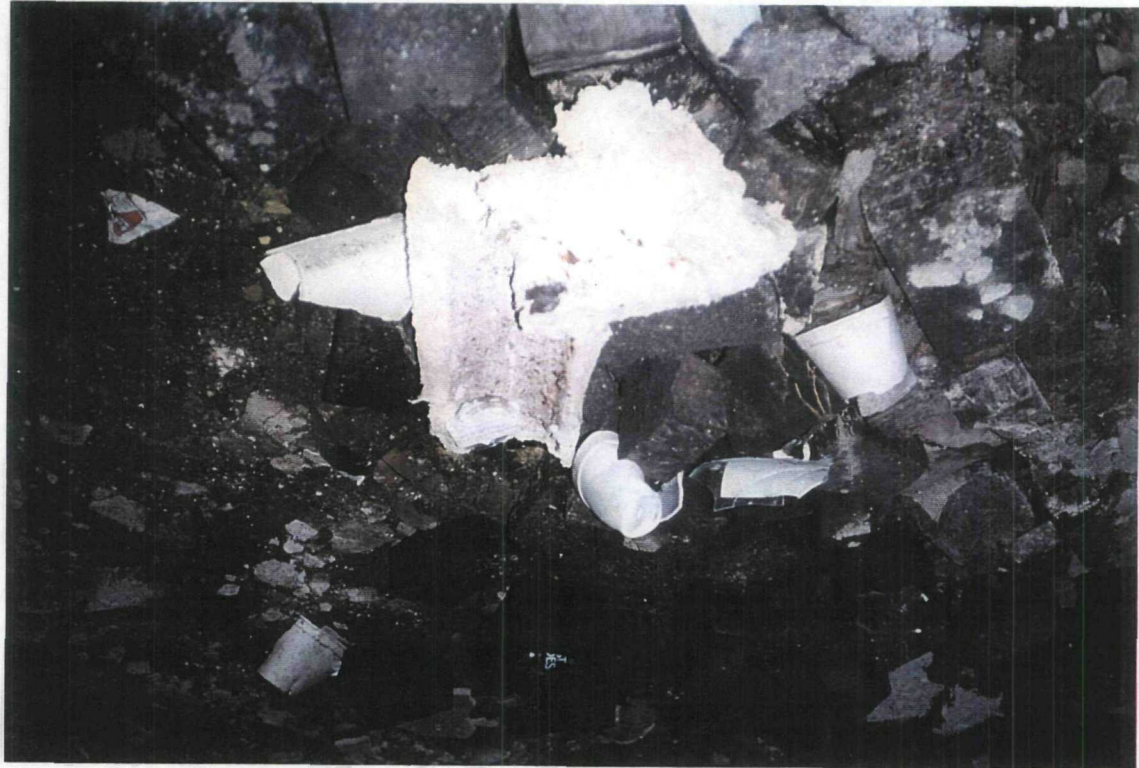
SAMPLE ID:  
HA00701

White, friable, fibrous pipewrap from ceiling pipe on first floor of building 23.

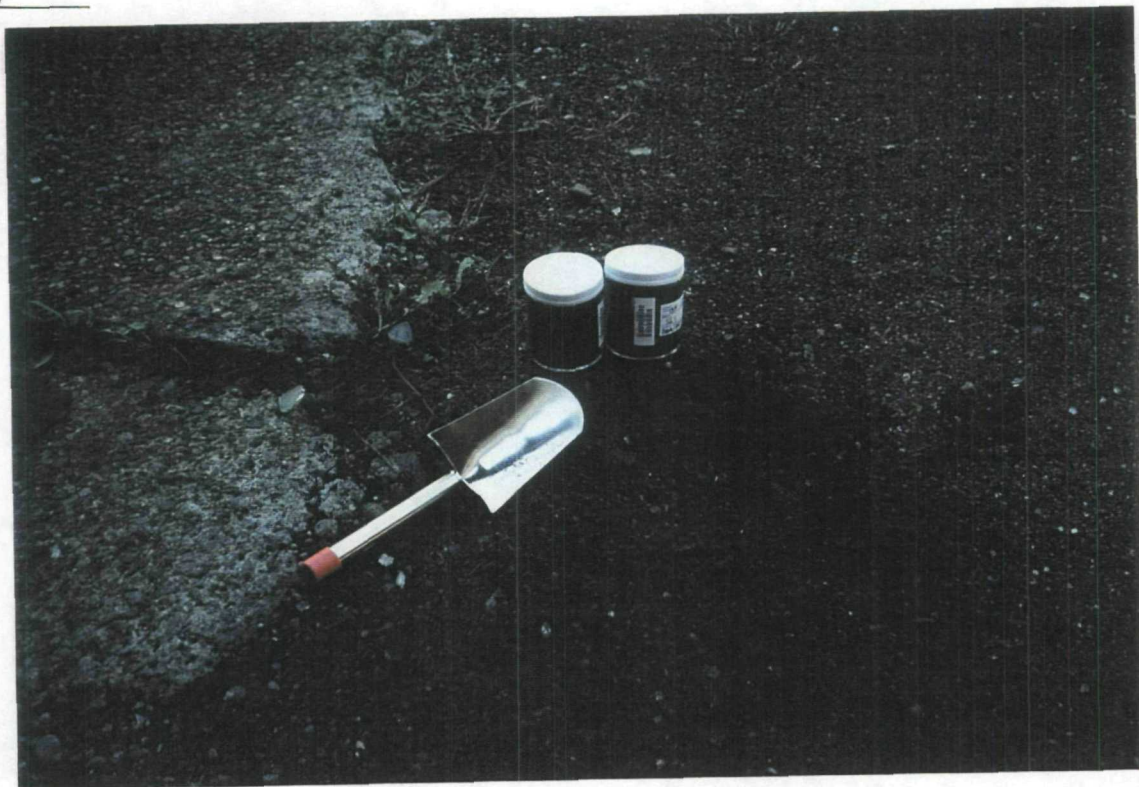
SAMPLE ID:  
SS 1

Surficial Soil 1 collected from area of stained soil west of Building 7 and east of Railroad Tracks.

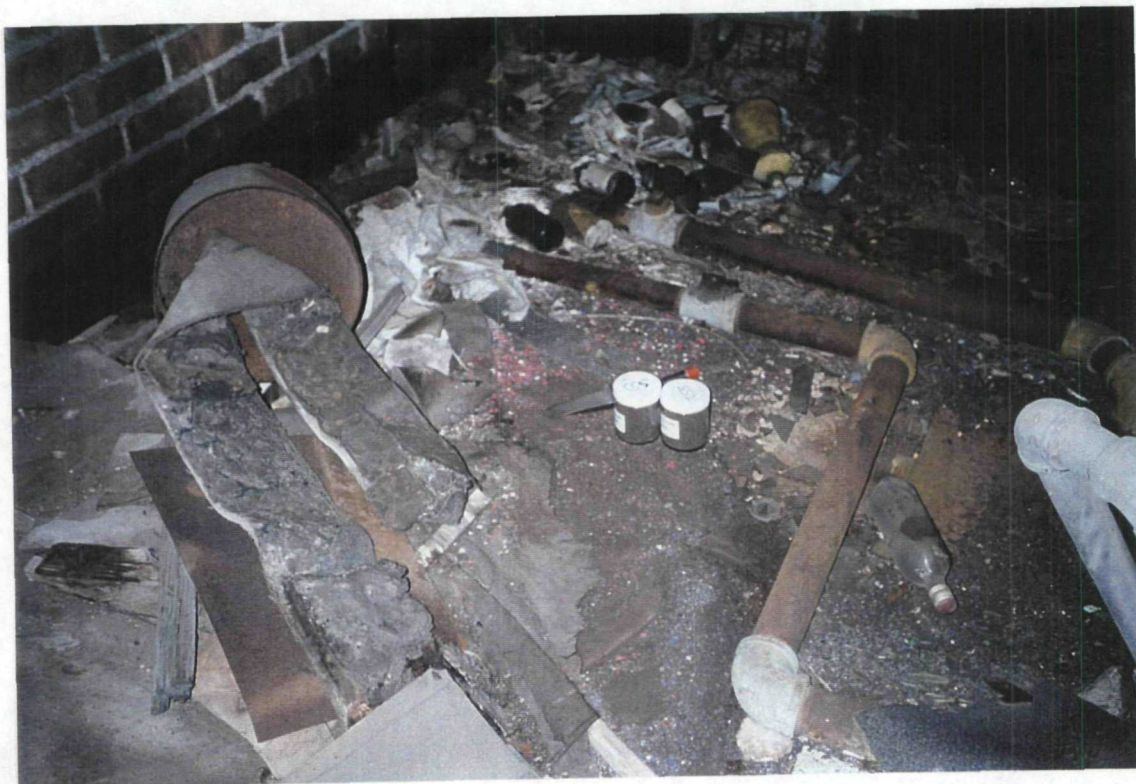
SAMPLE ID:  
SS 2

Surficial Soil 2 collected from stained soil inside pumphouse located along the outer west face of Building 9.

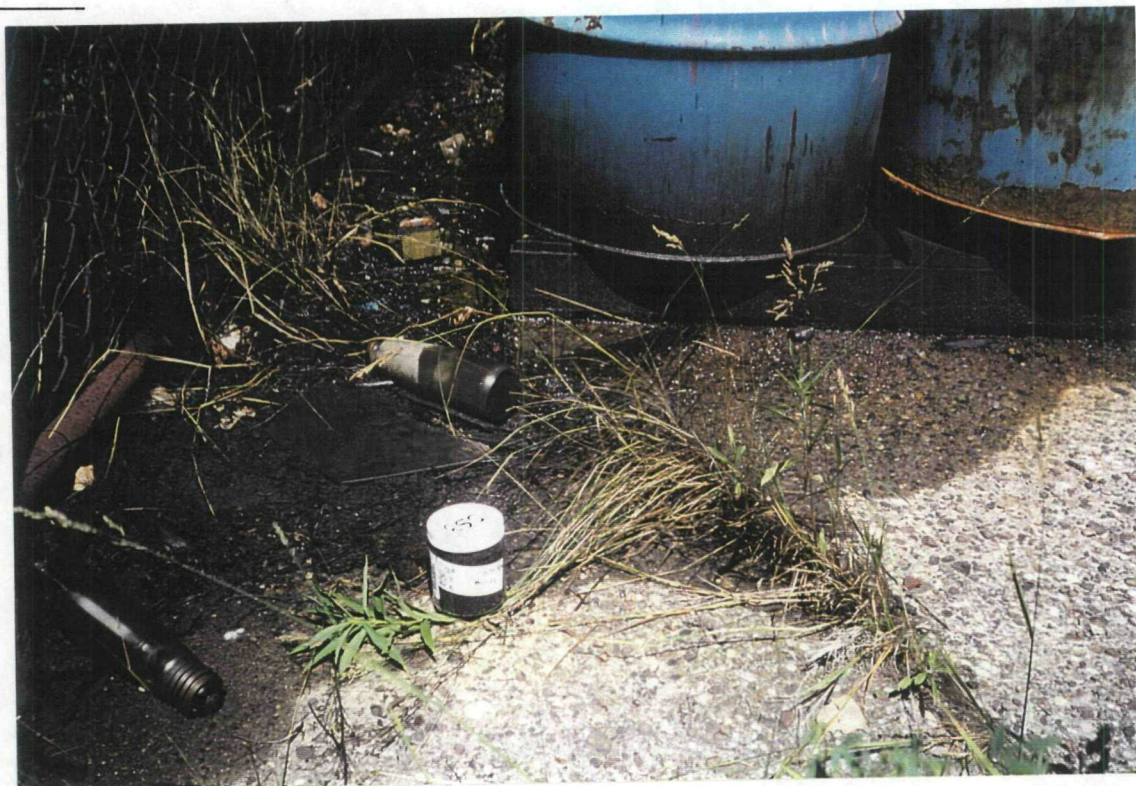
SAMPLE ID:  
SS 3

Stained soil around barrels west of Building 7/8/9, sample location.

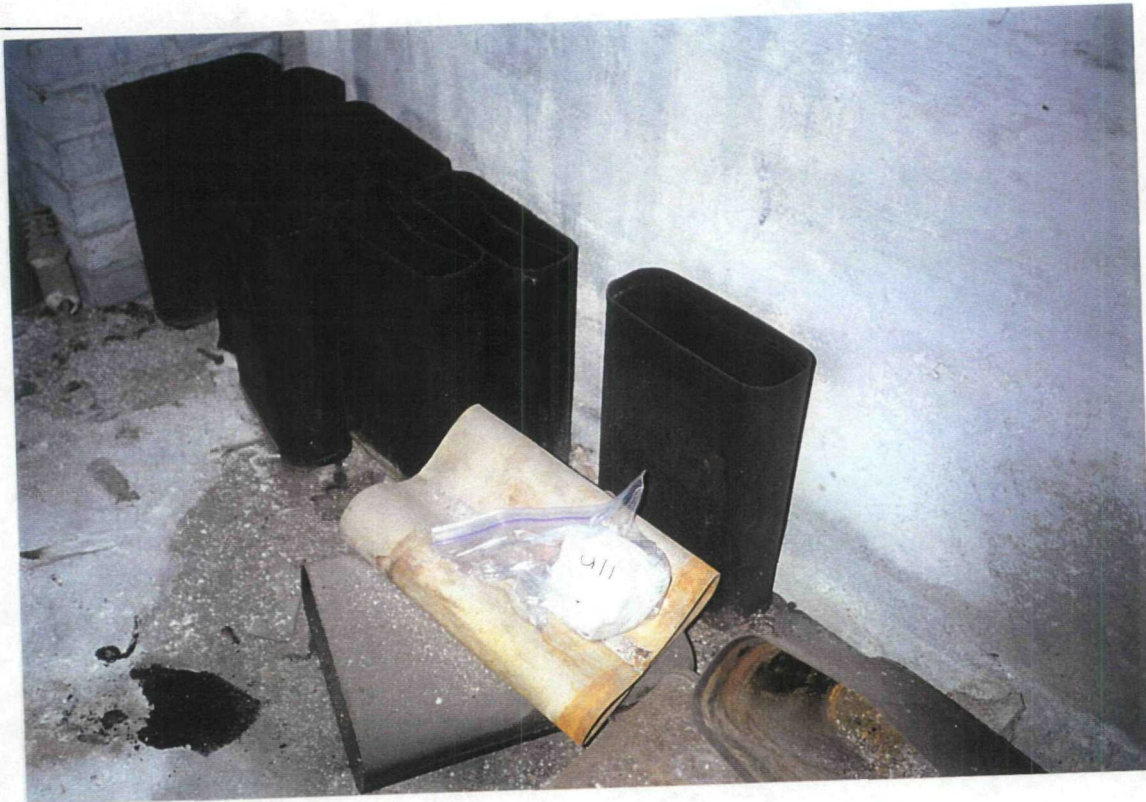
SAMPLE ID:  
OIL 1

Oil Sample 1 collected from capacitor carcasses located on the third floor of Building 35,38 in the southeast corner near elevator shaft, stairwell and electrical room.

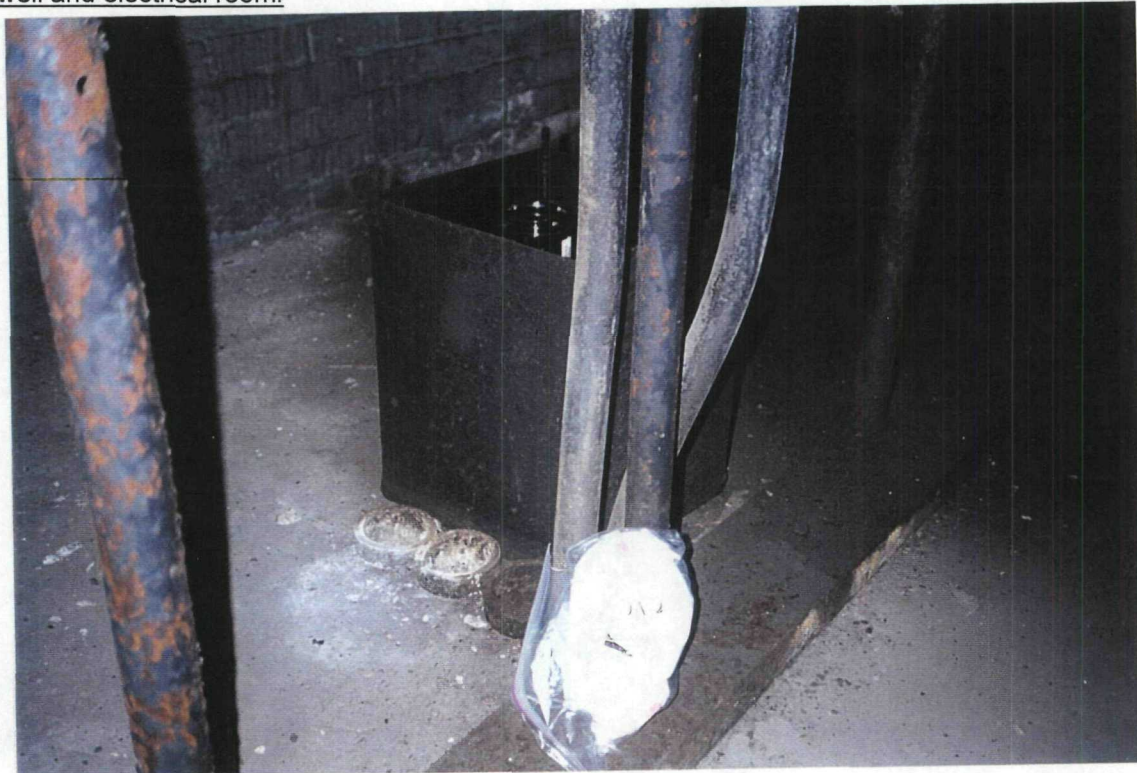
SAMPLE ID:  
OIL 2

Oil sample 2 collected from capacitor carcasses located on the third floor of Building 11,12 found in electrical room near elevator and entranceway to office area of Building 13.

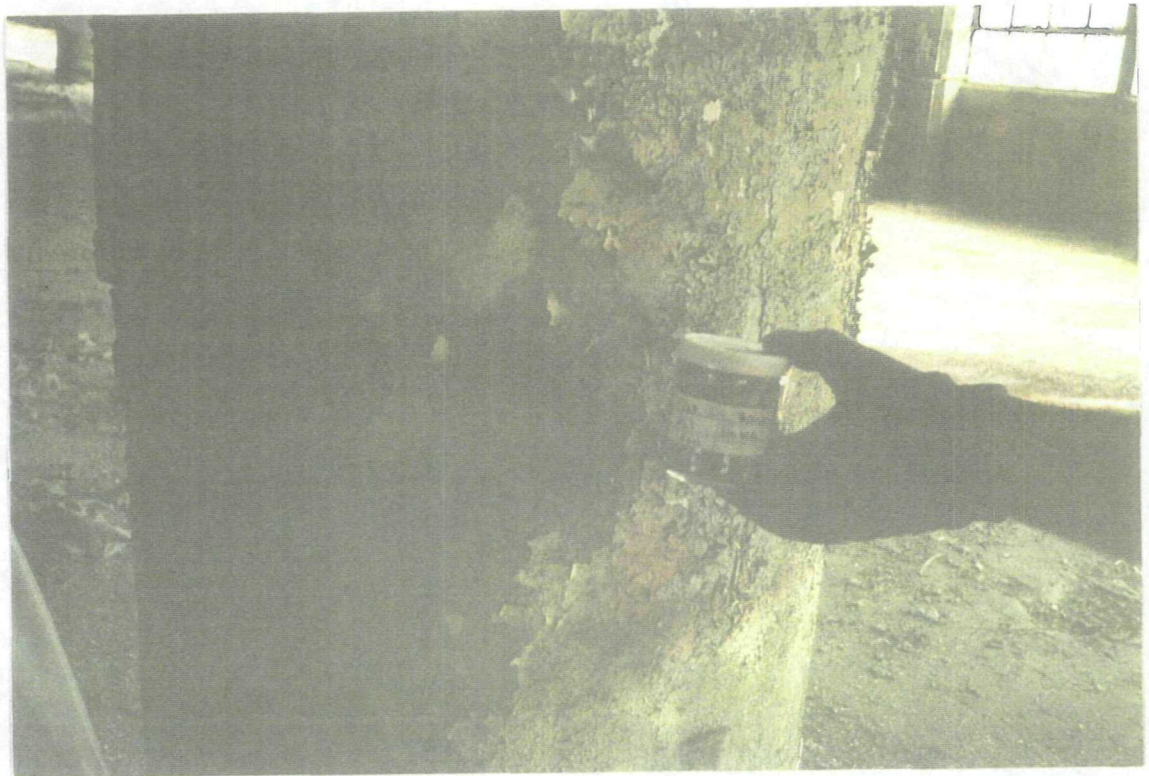
SAMPLE ID:  
PC 1

- Elevated concentrations of lead in paint throughout the complex. Intact lead based paint poses little threat to human exposure via the direct contact route. However, peeling lead based paint which was observed in portions of the complex buildings or removal of lead based paint during renovation, may release paint particle dust which may pose an inhalation threat to workers and nearby resident populations.

Paint Chip Sample 1 collected from a column located on the third floor of Building 38, labeled 35W3F3, in the southeast corner of the floor.

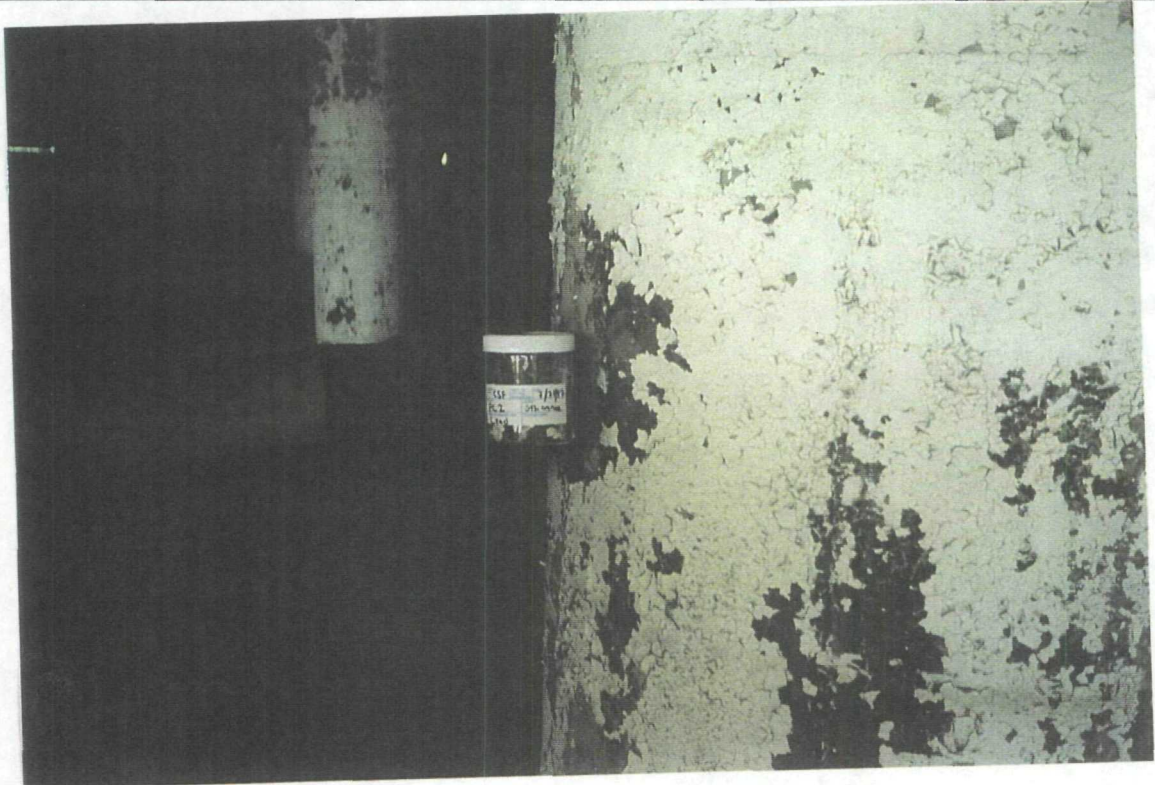
SAMPLE ID:  
PC 2

Paint Chip sample 2 collected from column on third floor of Building 92 at the Bellevue overpass connector entrance.
